DRIVERS OF IRRIGATION INEFFICIENCIES AND GROUNDWATER  
SITUATION AT JOYANWALA CATCHMENT, SHEIKHUPURA, PUNJAB

WATER PRODUCTIVITY (WAPRO PROJECT)

Date: October, 2018

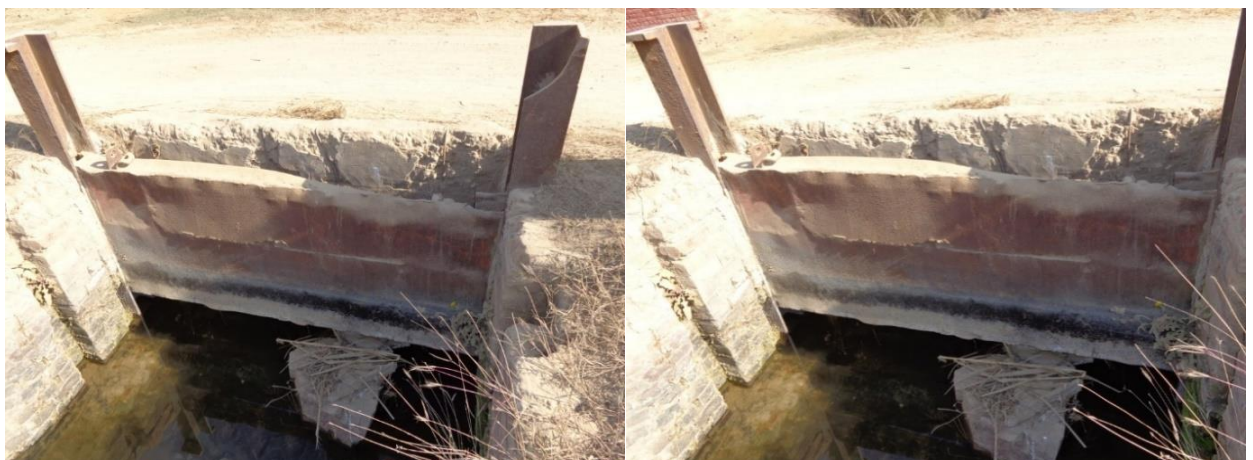
A regulating structure is provided to regulate the flow across the channel. It can be either cross regulator (across the channel) or head regulator (off-taking point of a channel). Regulating structure is of utmost importance for proper regulation of water to the conveyance channel. In the subject study, head regulator of Joyanwala minor was found damaged/non-operational. This leads to the fluctuating supply in the channel and may lead to water shortage along the channel. Head regulator of Joyanwala distributary is shown in **Figure2**.

**Figure 2. Head regulator of Joyanwala distributary**

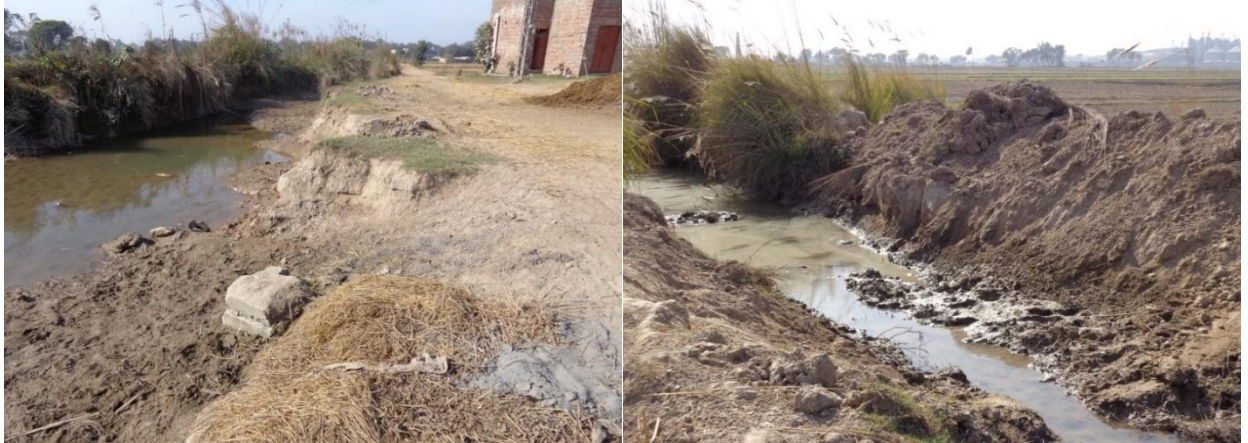
Canal banks play a vital role in carrying water to the entire length of the channel. Inadequate maintenance and poor/weak banks result in frequent breaches and are vulnerable to water theft activities. The banks of the channel were found eroded in several reaches throughout especially in the first half. Excessive bank erosions have also caused excessive water losses and less efficiency of canal system due to channel breaches. Inadequate bank maintenance of Joyanwala distributary shown in **Figure3**.

Figure 3. Inadequate bank maintenance on Joyanwala distributary

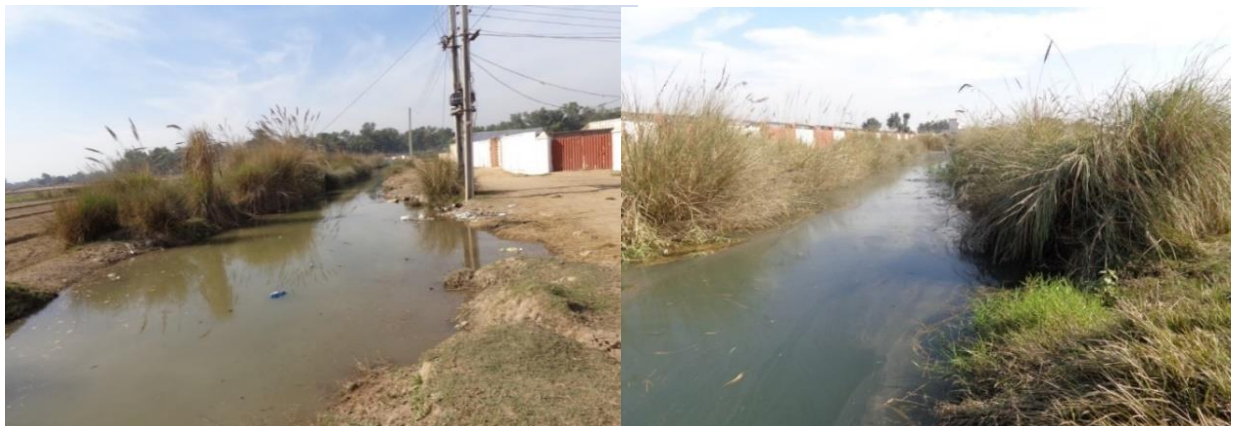
'Free board' is described as the difference between Full Supply Level (FSL) from the top of channel bank level. During site visit, the water marks on the banks confirmed that recommended freeboard of 1ft was not available along the channel because of bank erosion, weather action, less maintenance and widened sections. It resulted in poor canal operation and inequitable distribution of canal water. The freeboard was also found short at the upstream of some hydraulic structures. Inadequate free board on Joyanwala distributary shown in **Figure4**.

Figure 4. Inadequate free board on Joyanwala distributary

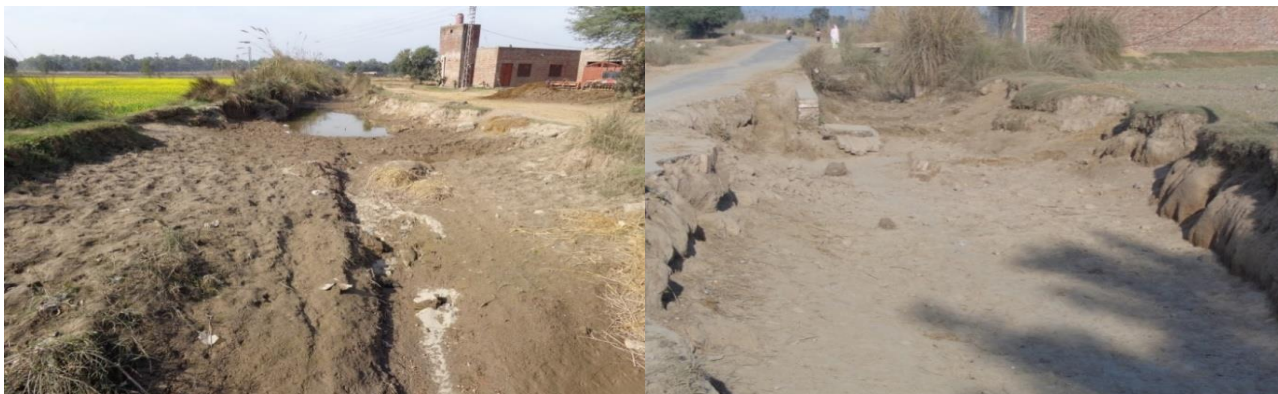
Side embayment was found at Joyanwala minor resulting in poor condition of channel prism and damaged protection walls (Figure 5). The undulating flow pattern of Joyanwala minor has caused channel instability and side embayment. Trespassing of domestic animals from the nearby areas into the channel is also a major source of deterioration of the channel prism.

Figure 5. Poor condition of Joyanwala distributary prism

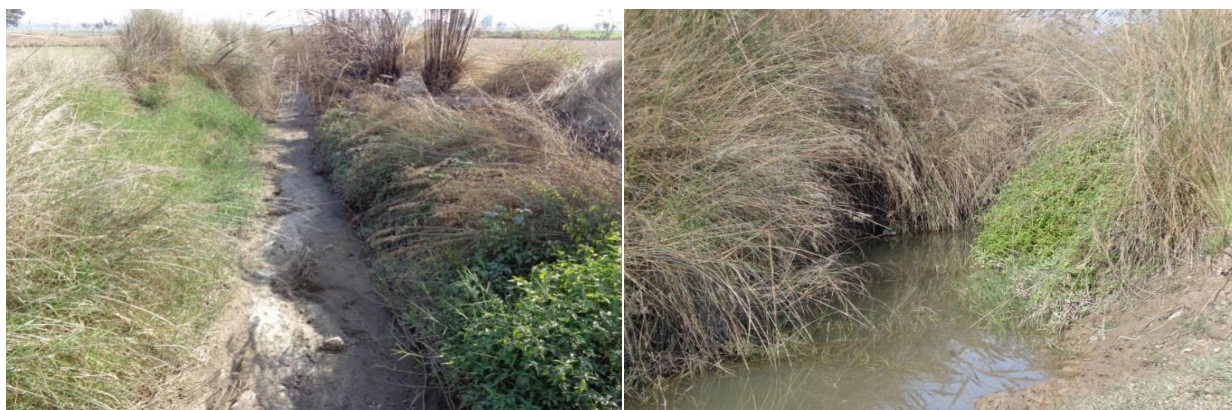
Excessive vegetative growth was observed through the entire length of the channel resulting in obstruction to a smooth flow of the canal water and shortage at tail of the distributary.

Figure 6. Weeds/vegetation on Joyanwala distributary

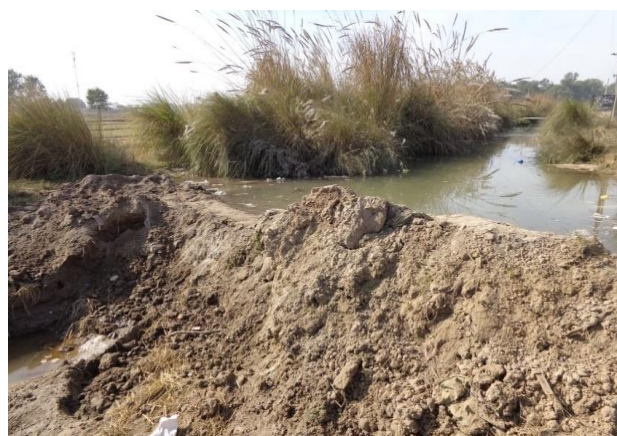
Water theft has been a major concern for Joyanwala distributary. Farmers do have the tendency to apply unauthorized means (cuts, pipes, illegal obstruction in the flow of water) to irrigation whenever there is supply available in the channel. This also contributes towards shortage of supply at tail. Water theft sites on Joyanwala distributary shown in **Figure7**.

Figure 7. Water theft sites on Joyanwala distributary

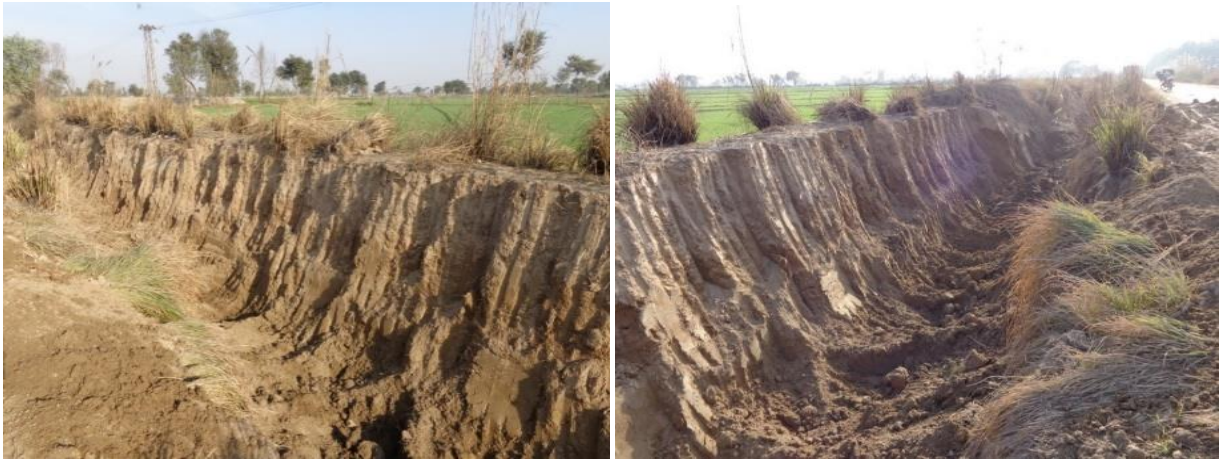
During the visit of Joyanwala Distributary, it was observed that bed and banks of some reaches especially middle to tail was deepened by using excavator. All this was done in an attempt to carry the water at tail. This resulted in disturbance of channel prism and resultantly all the outlets in the reach were not getting their full share of water. Improper desilting of channels on Joyanwala distributary is shown in **Figure 8**.

**Figure 8. Improper desilting of channels on Joyanwala distributary**

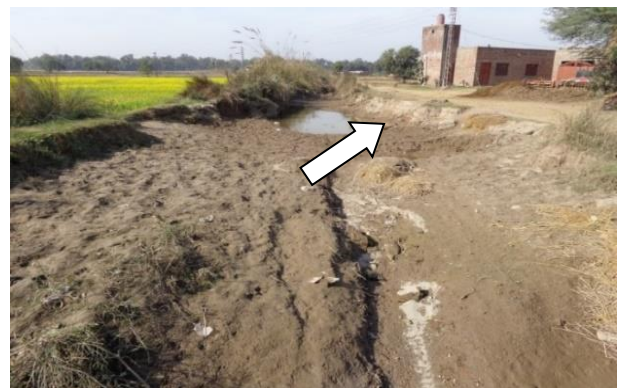
Encroachments along the channel were observed in the form of cattle sheds, and houses. All such encroachments result in deterioration of channel banks and widening of channel prism.

**Figure 9. Encroachment on Joyanwala distributary.**

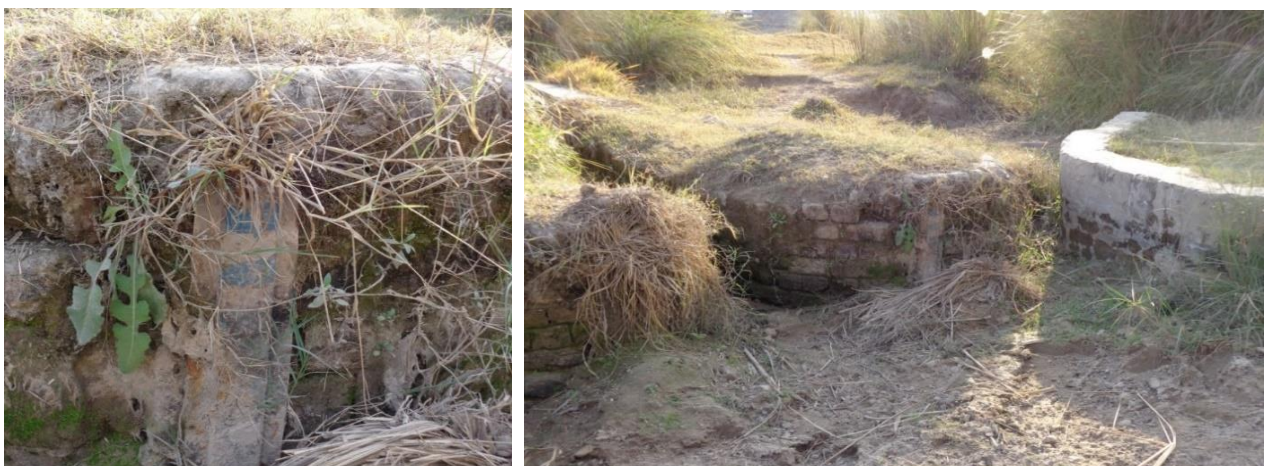
Tail structure of Joyanwala distributary was found in poor condition as deposits of debris were seen around tail structure creating obstruction in the flow of water. Condition of water courses at tail cluster were also found poor due to lack of maintenance by local irrigators. Tail measuring gauge was also in deteriorated condition and the true picture of water supply at tail could not be assessed.

**Figure 10. Poor tail maintenance**
