DRIVERS OF IRRIGATION INEFFICIENCIES AND GROUNDWATER  
SITUATION AT JOYANWALA CATCHMENT, SHEIKHUPURA, PUNJAB

WATER PRODUCTIVITY (WAPRO PROJECT)

Date: October, 2018

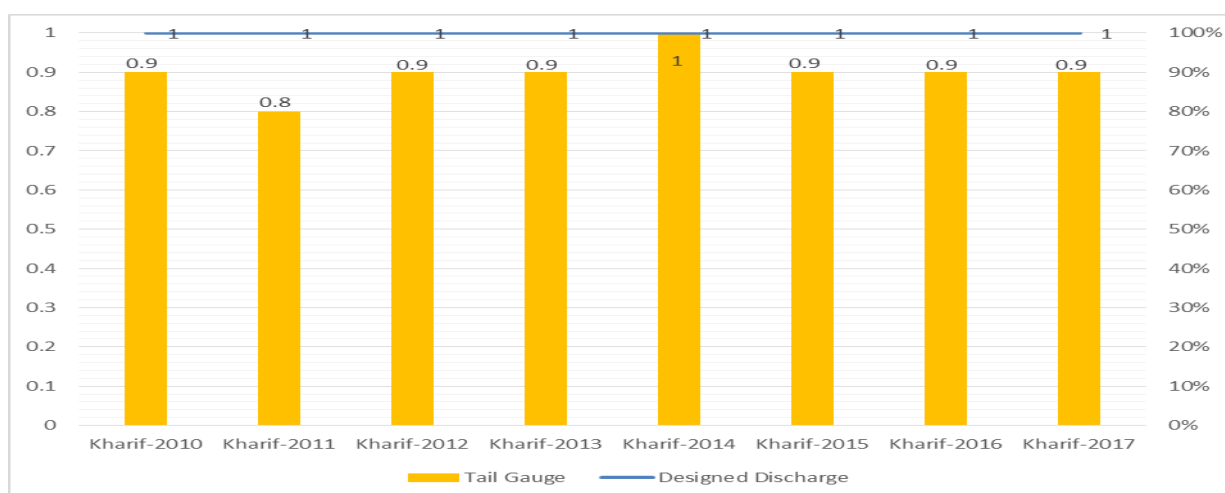
**Figure 12. Water availability at tail of Joyanwala distributary;**  
**Source: Irrigation Department, Govt. of Punjab**

Similarly, supply of water at tails was also analysed and it was observed that supply of water at tail has generally been satisfactory except for the year 2011 when the channel got less supply from the head despite which, the graphical presentation shows better delivery of water at tails. Some farmers complained about shortage of water at tails which is because that channel gets its volumetric entitlement by the end of the season and there are fluctuating supplies in mid-season. As the authorized tail gauge (depth of water over the tail cluster outlets) is 1.0ft, the delivery at tail is usually approximately 0.90ft (**Figure 12**).

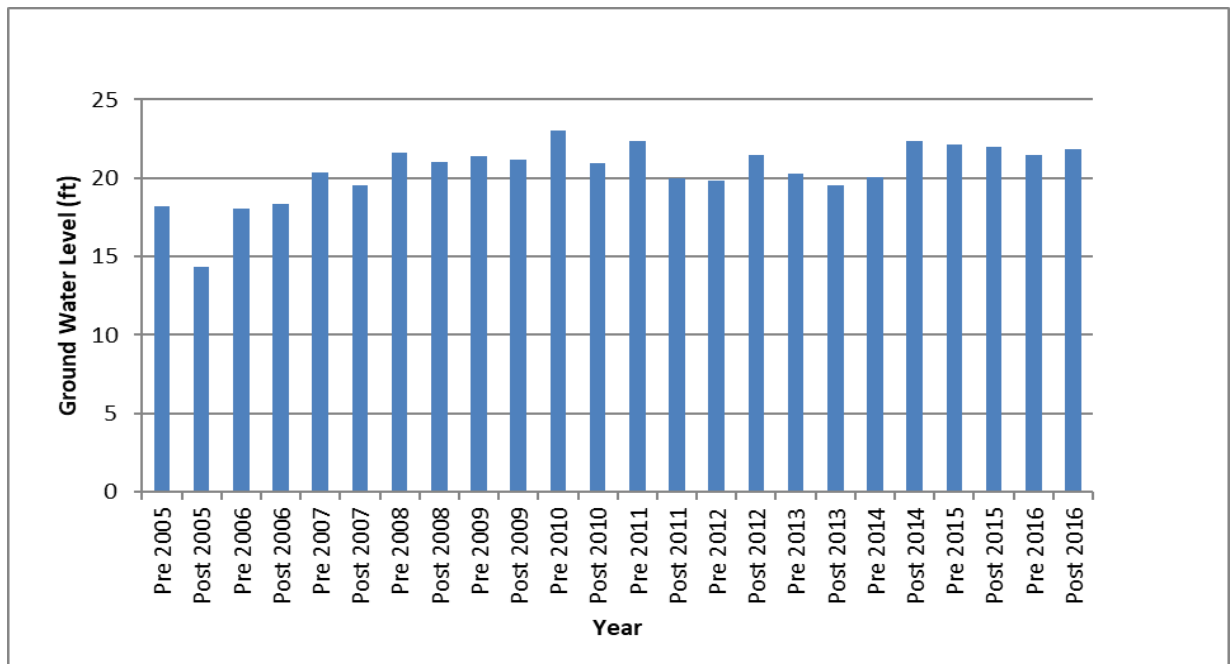
**Figure 13. Position of groundwater level near Joyanwala village;**  
Source: Irrigation Department, Govt. of Punjab.

Groundwater analysis for water table and quality has been done on the basis of available data for the last 10-15 years (**Figure 13**). The data includes groundwater table position for both pre and post monsoon/flood season. The figure shows that average position of water table in the area is 20ft below ground level. Joyanwala village covers the head reach (first 1/3<sup>rd</sup> portion) of the channel. The most likely reason for availability of water at a shallower depth is that the area is engulfed between Upper Chenab Canal and Joyanwala distributary. Hence seepage from main canal is a continuous source of groundwater recharge. However, quality of this groundwater is questionable as local farmers have their tube wells installed at more than 100ft depth.

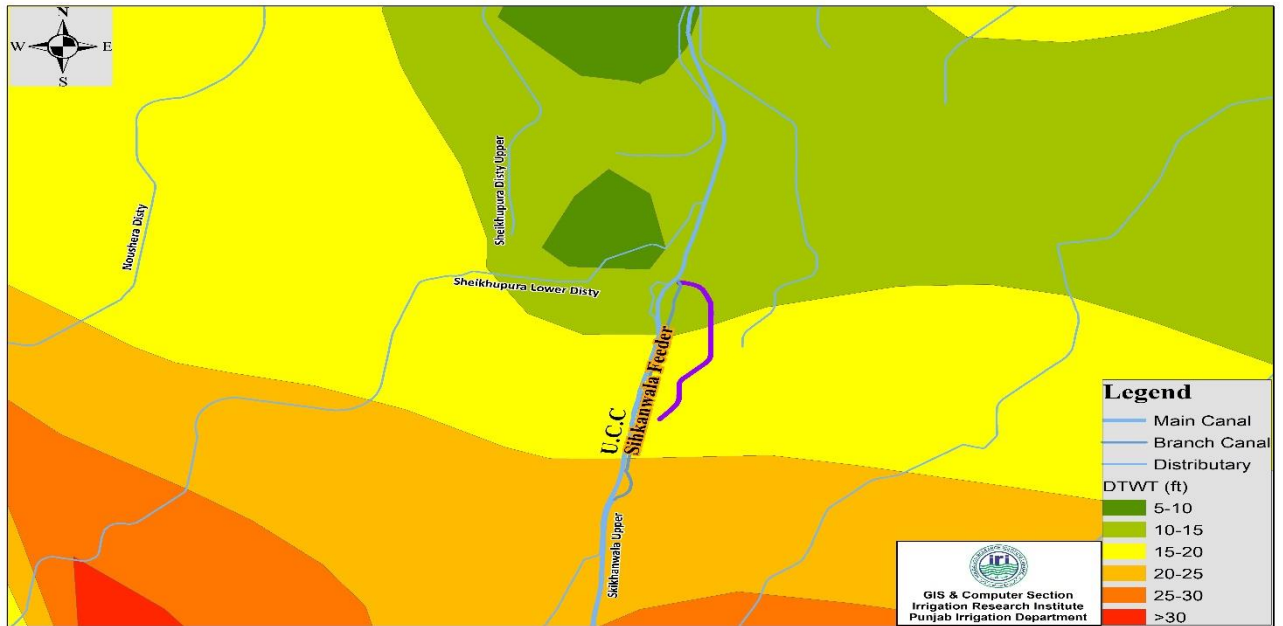
Figure 14. Depth to water table map for pre monsoon 2016

Spatial distribution/pattern of depth to water table in the area is depicted in the **Figures 14 and 15** which show that the groundwater becomes deeper as we move from head to tail reach of the channel, which can be attributed to the more pumping in the command area falling at the tail.

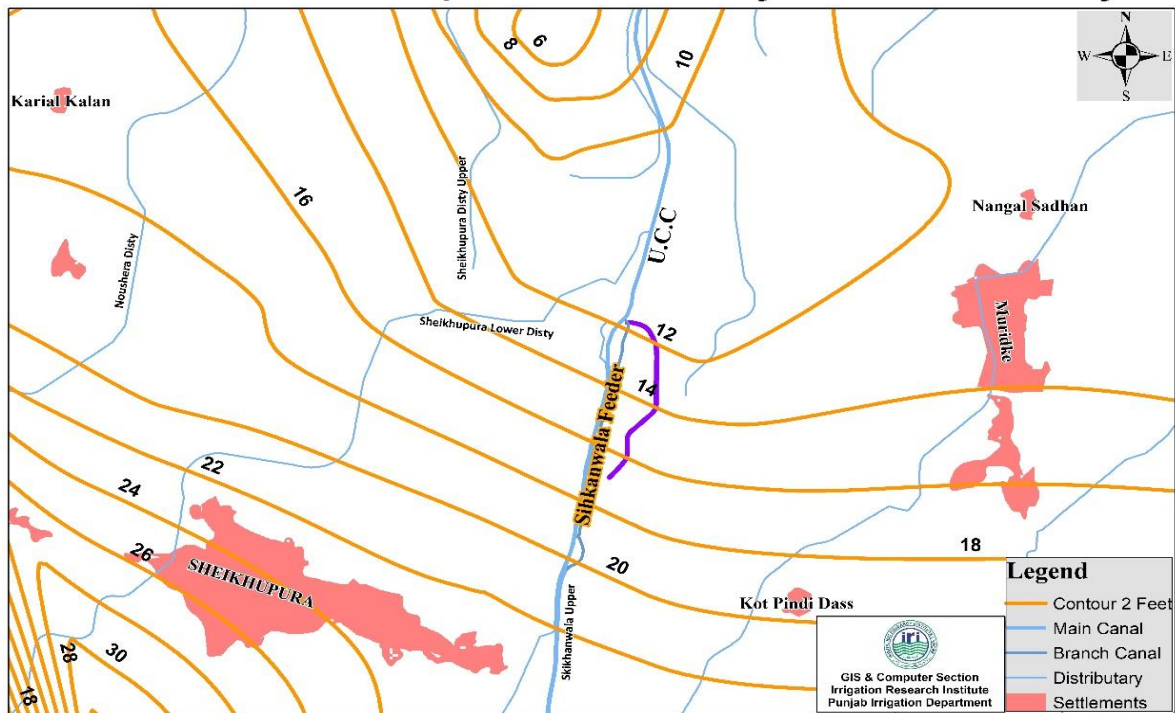
Figure 16. Contours of depth to water table post 2015 (ft below NSL)

Contour plot of depth to water table is shown in **Figure 16** which indicates that water table in the vicinity of Joyanwala distributary falls in the range of 12 to 18 ft. below the natural land surface (NSL). It can further be observed that as we move from head to tail reach the groundwater level becomes deeper and also the groundwater flow pattern is almost parallel to the channel. Groundwater becomes deeper towards the Sheikhupura city which might be due to excessive pumping in the city area.

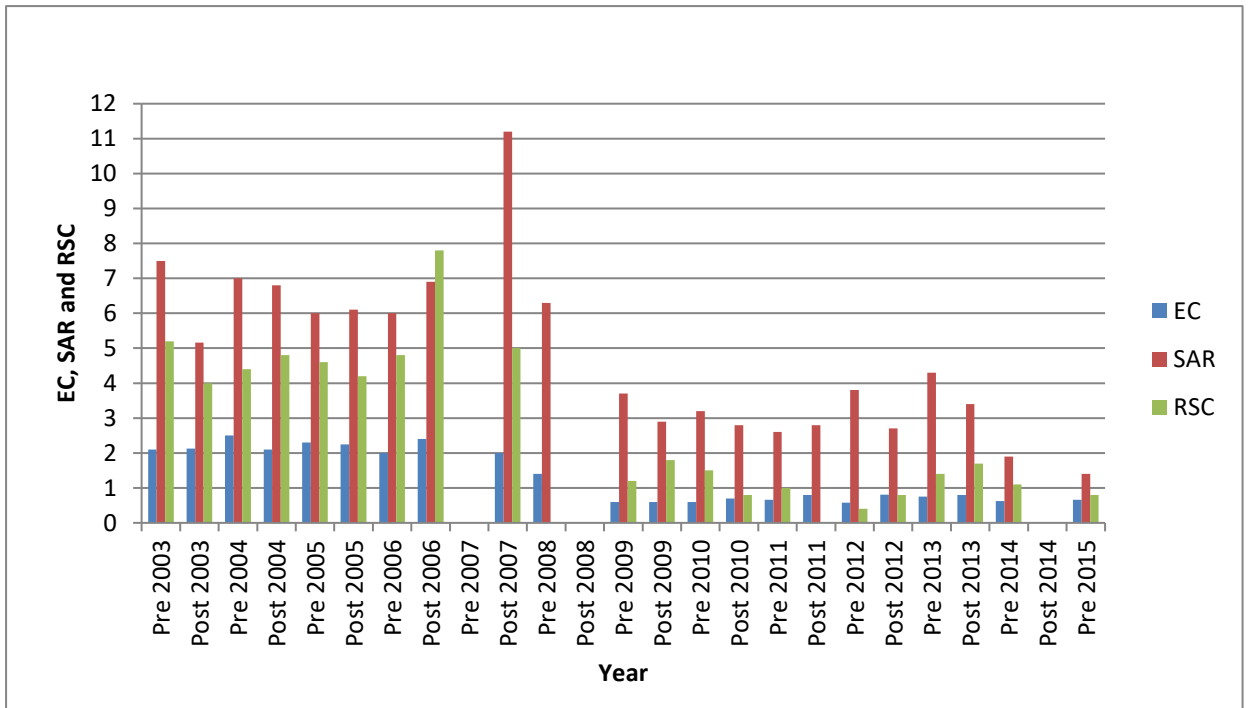
**Figure 17. Pre and post monsoon ground water quality analysis near Joyanwala village;**  
**Source: Irrigation Department, Govt. of Punjab.**

Figure 15 and 16 show varying trends in SAR values for both Joyanwala and Chak Sanata villages. Groundwater analysis of Chak Sanata shows higher SAR values after 2011 which indicates build-up of sodium level as compared to Joyanwala which has a reduced SAR value. According to the classification of groundwater on the basis of SAR value, the groundwater near

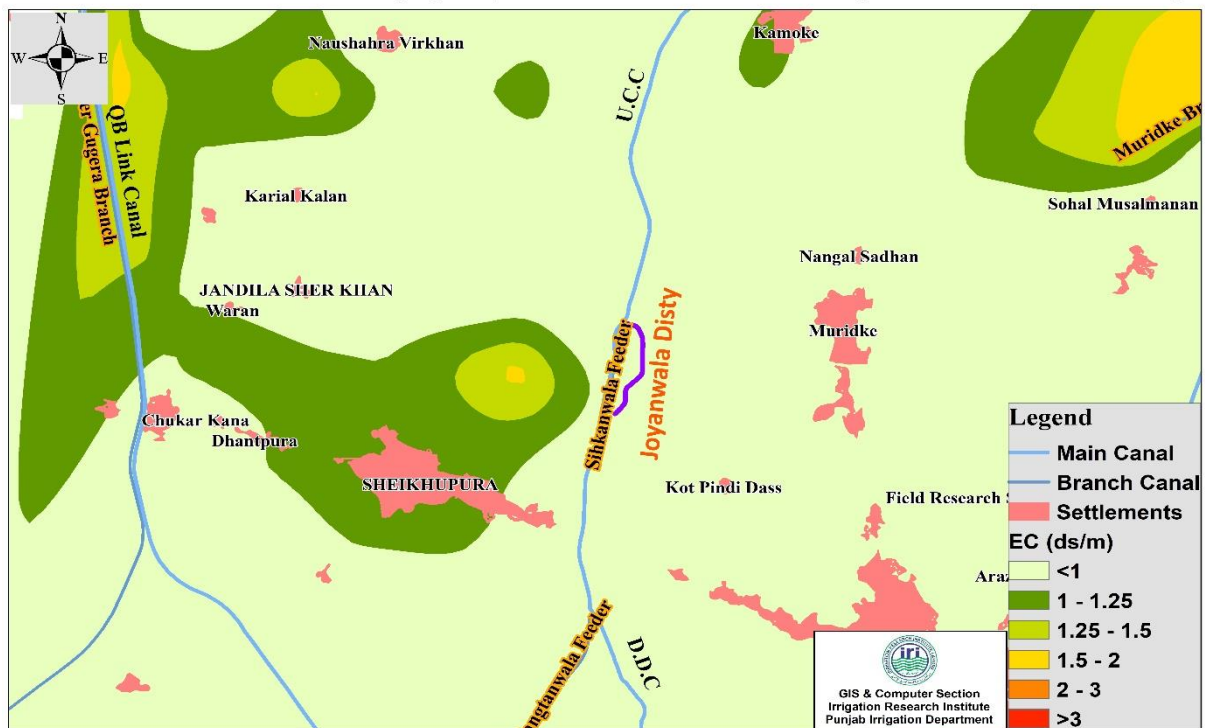
**Figure 19. Ec map of groundwater in the study area for 2013**

Spatial patterns of Ec, RSC and SAR for the study area as shown in **Figure19** respectively which indicate that groundwater quality is better in the vicinity of the Joyanwala Distributary and deteriorates as we move towards the Sheikhpura city. This is due to more pollution due the effluents from city and contamination the drainage network in the area.

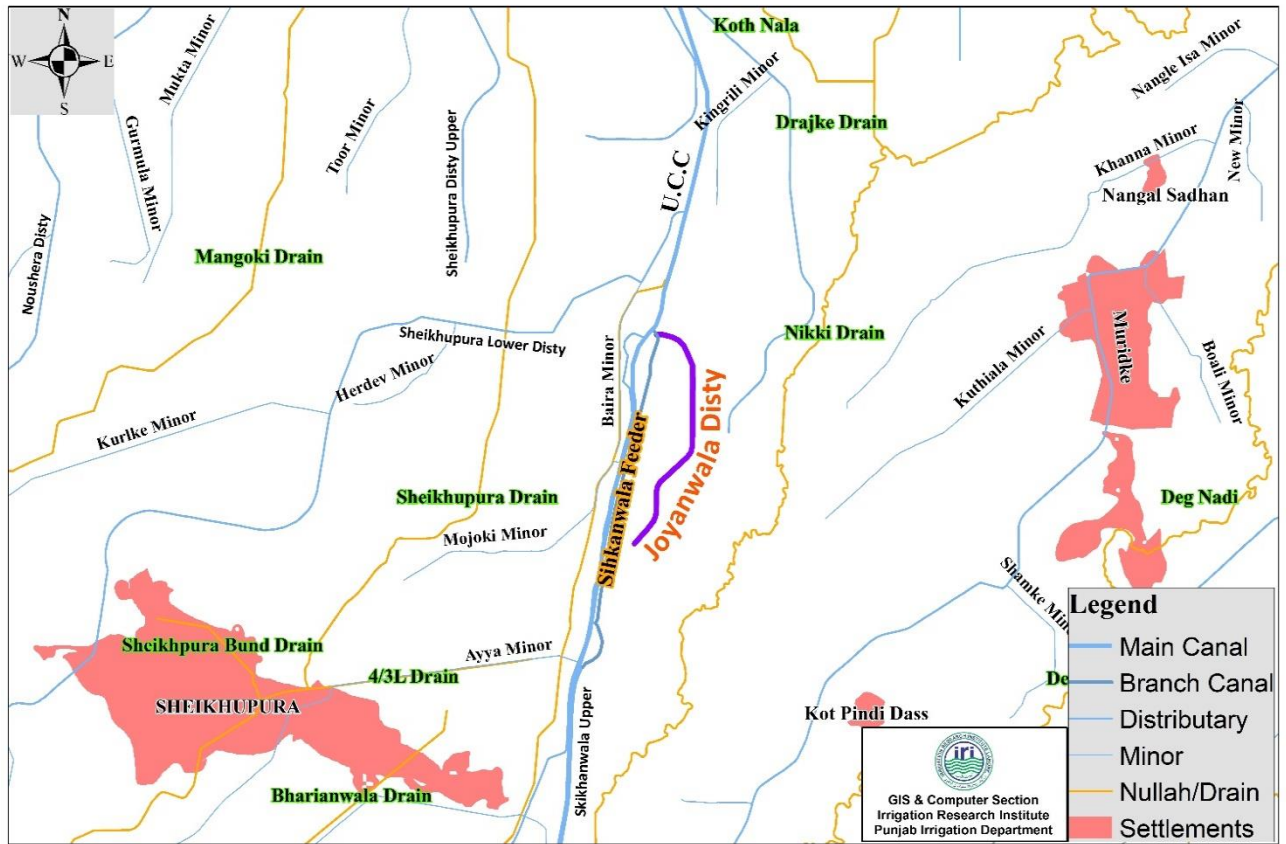
Figure 22. Location of surface drains in the study area

A number of surface drains are passing through the area carrying the domestic, industrial and agricultural effluents which are a source of degradation of land and groundwater resources due to leaching down of hazardous pollutants. List of drains is given in the box and location is shown in **Figure22**.
